## Robinson Helicopter Company Accident Report

AIRCRAFT MODEL:	<u>R44 Clipper I</u>
SERIAL NUMBER:	<u>1295</u>
REGISTRATION:	<u>N7530R</u>
ACCIDENT DATE:	<u>30 January 2018</u>
ACCIDENT LOCATION:	<u>Newport Beach, California</u>
NTSB IDENTIFICATION:	<u>WPR18FA077</u>

REPORT WRITTEN BY: Ken Martin

DATE: 17 June 2019

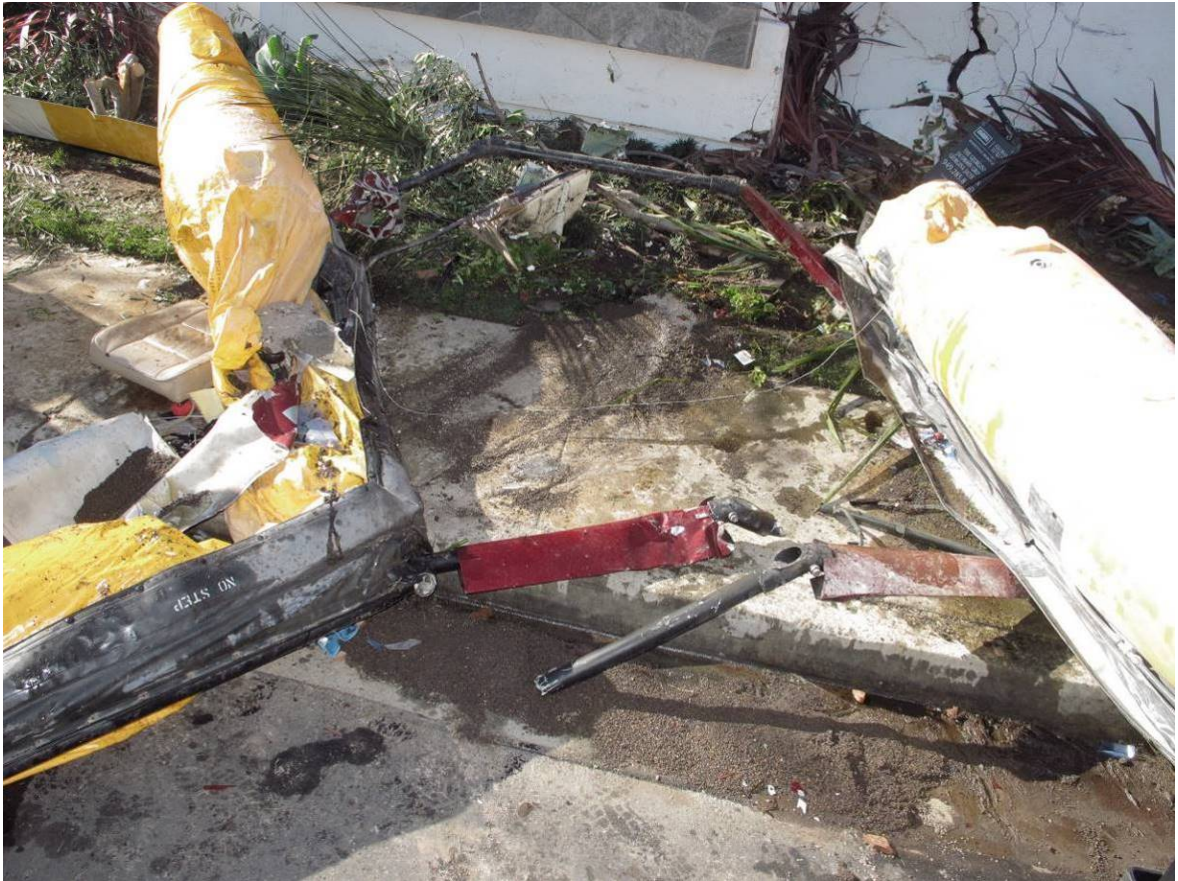
The landing gear was disconnected from the airframe at all four mounts. The bearing housings were fractured. The surfaces of the fractures were angular and jagged.

The landing gear at the accident site, after fuselage removal

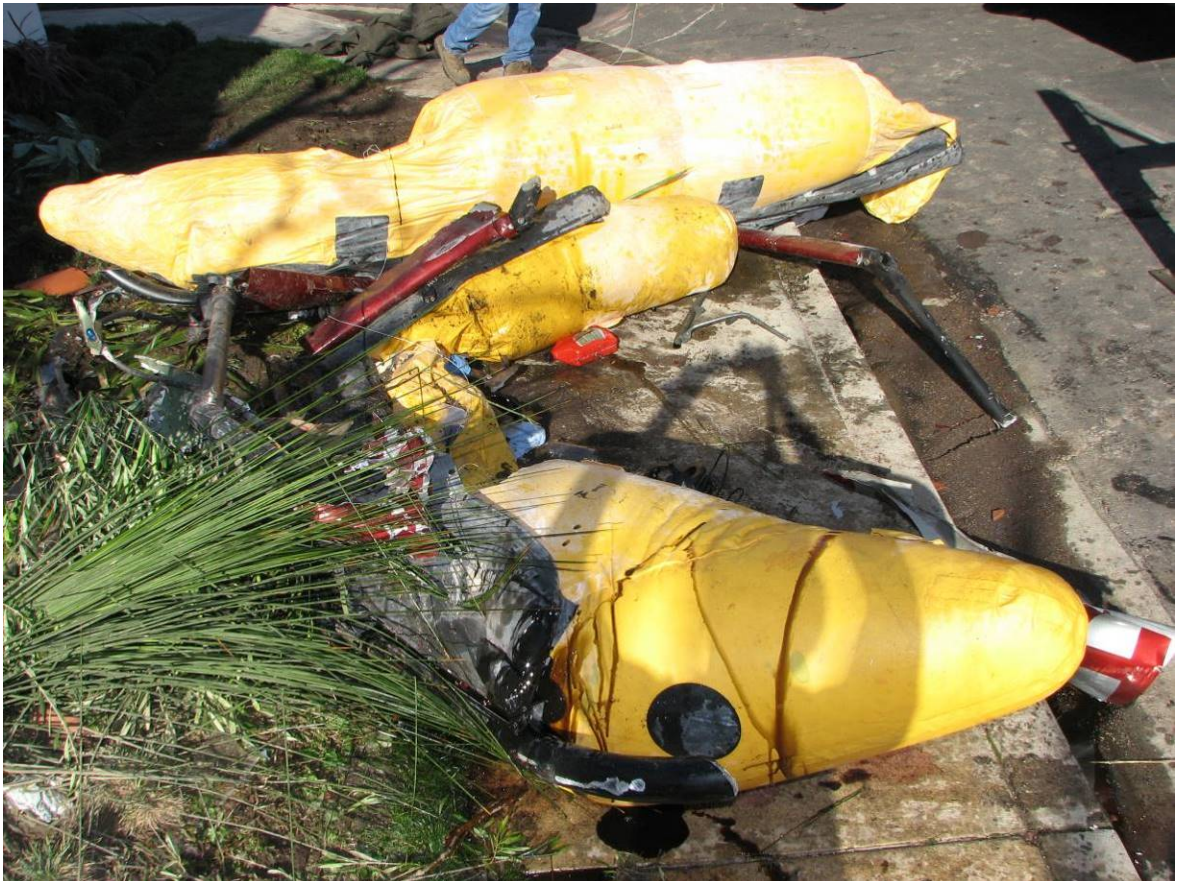
The landing gear at the accident site, after fuselage removal

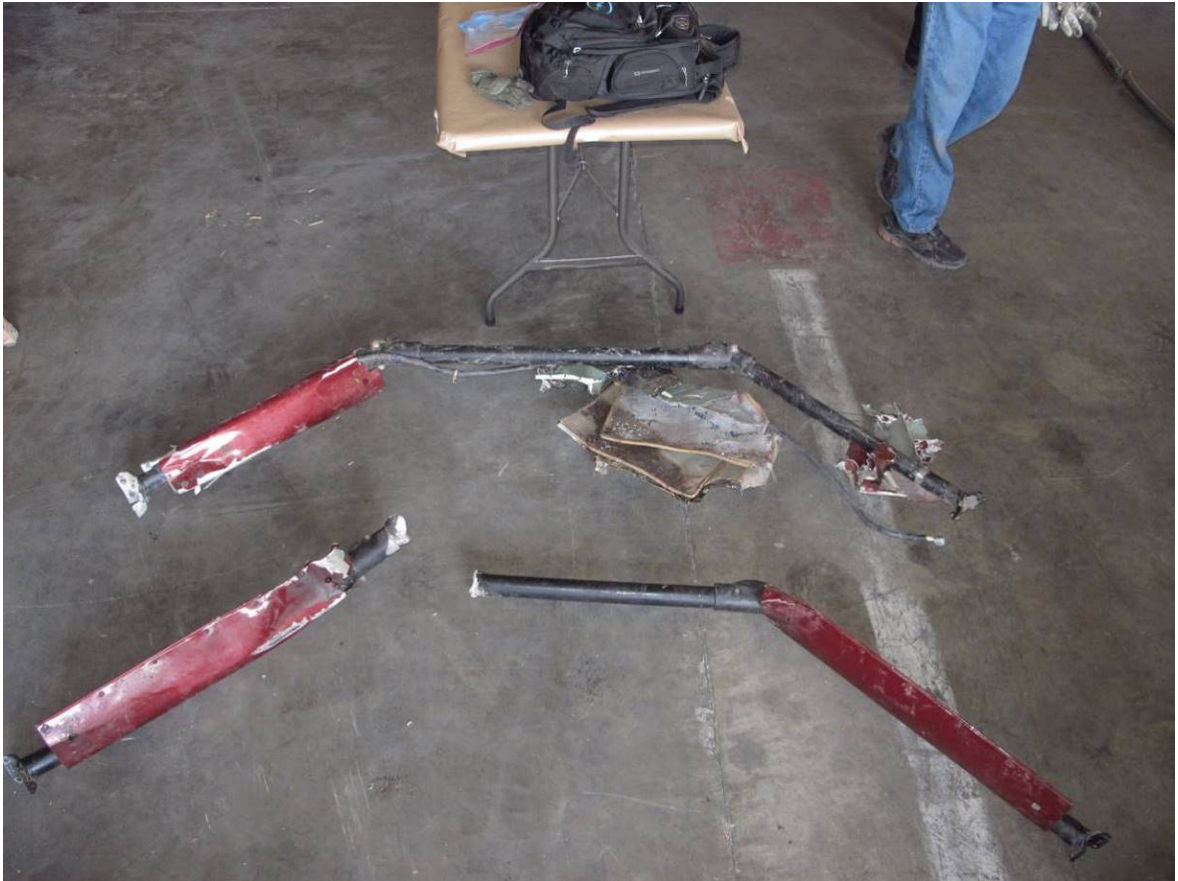
The landing gear cross tubes and struts

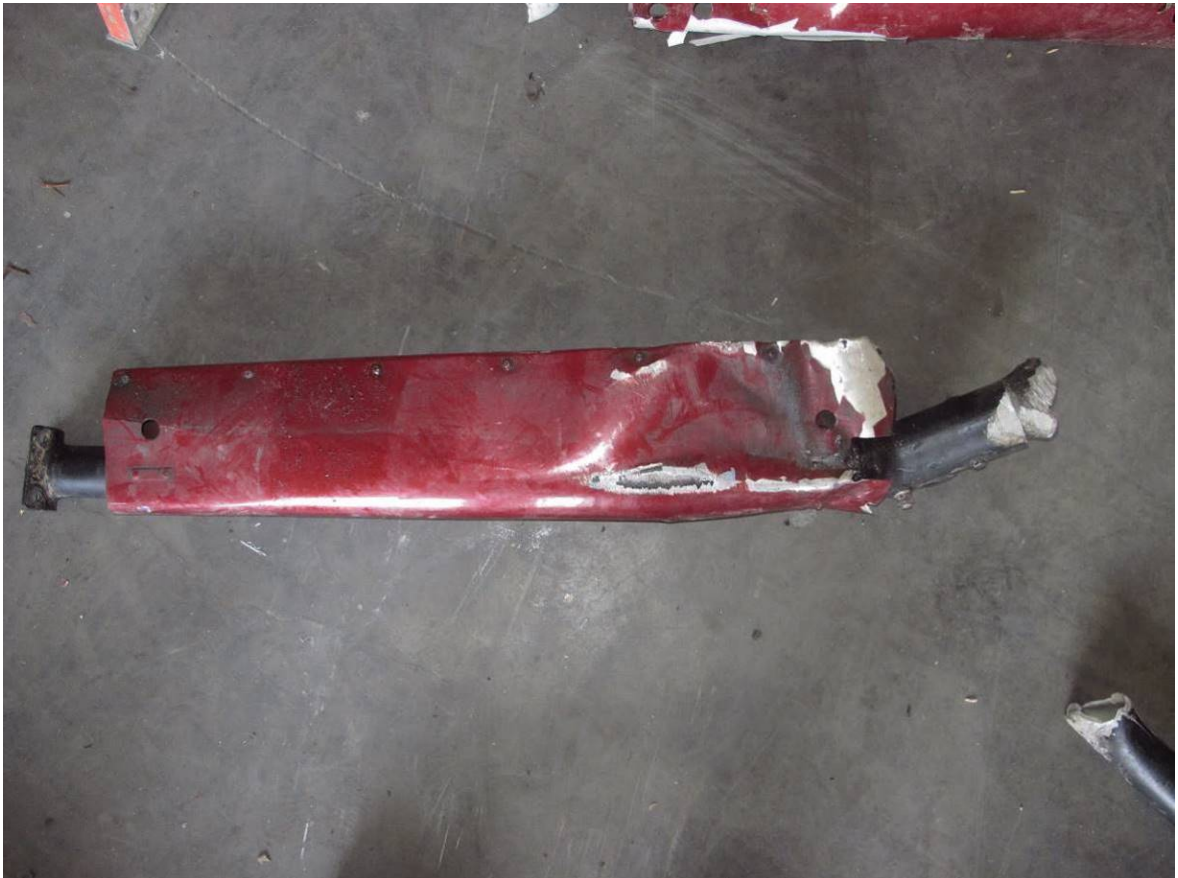
The left rear strut, from the bottom

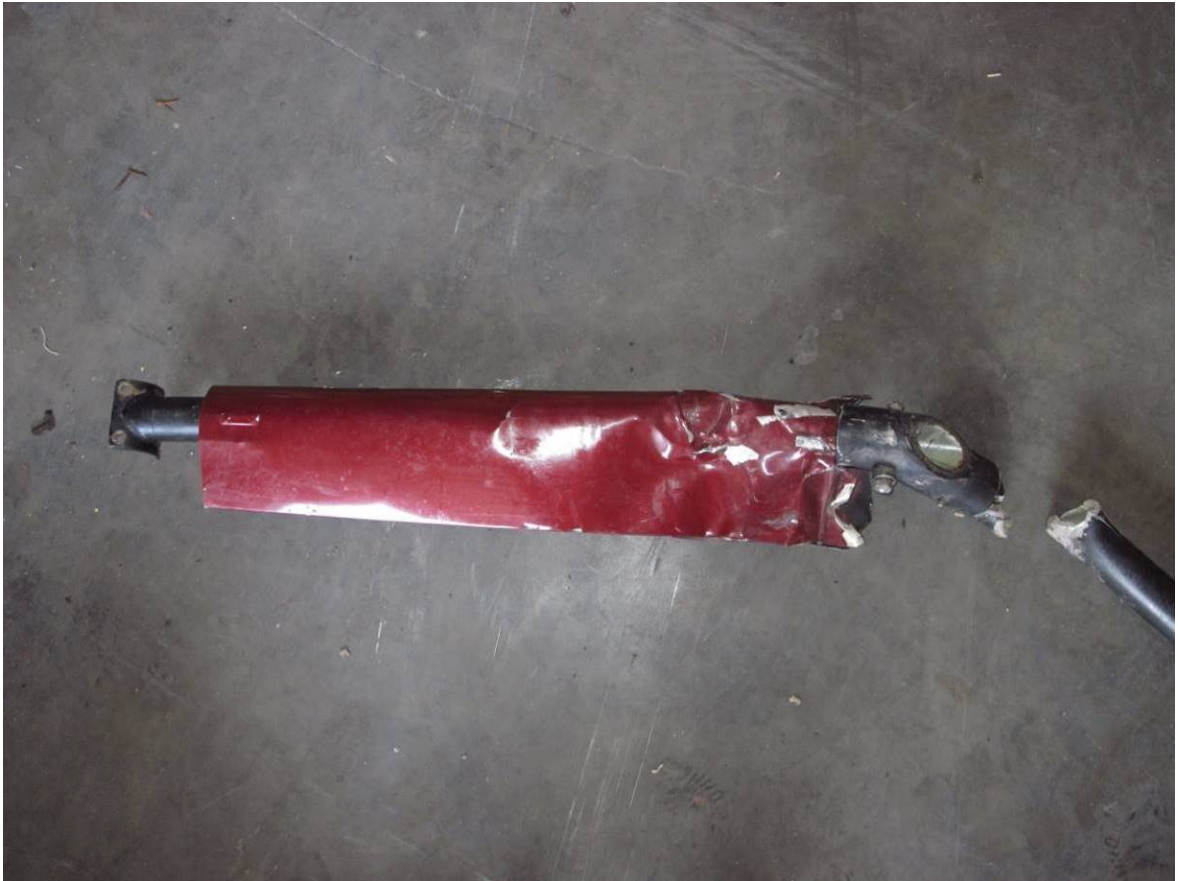
The left rear strut, from the top

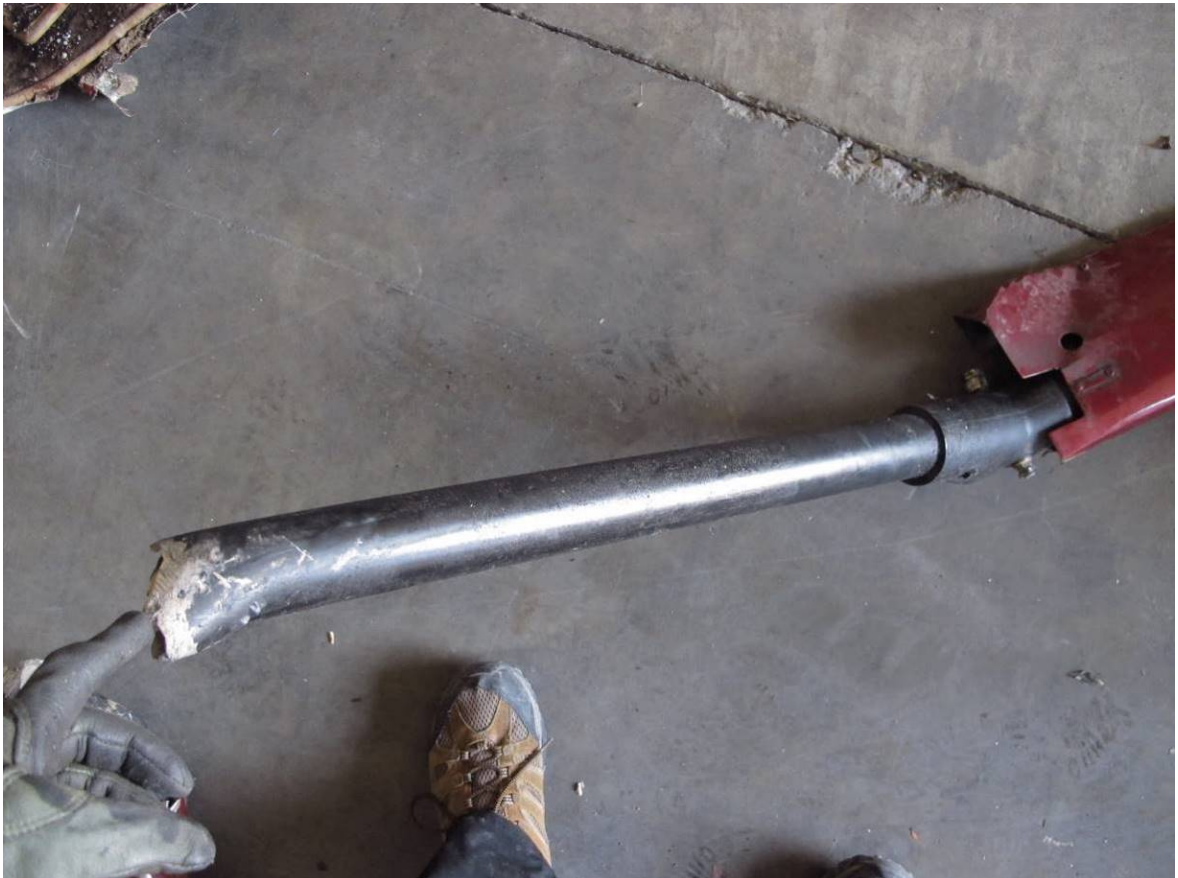
The aft cross tube was disconnected at the left elbow. The surface of the fracture was angular and jagged.

The rear cross tube

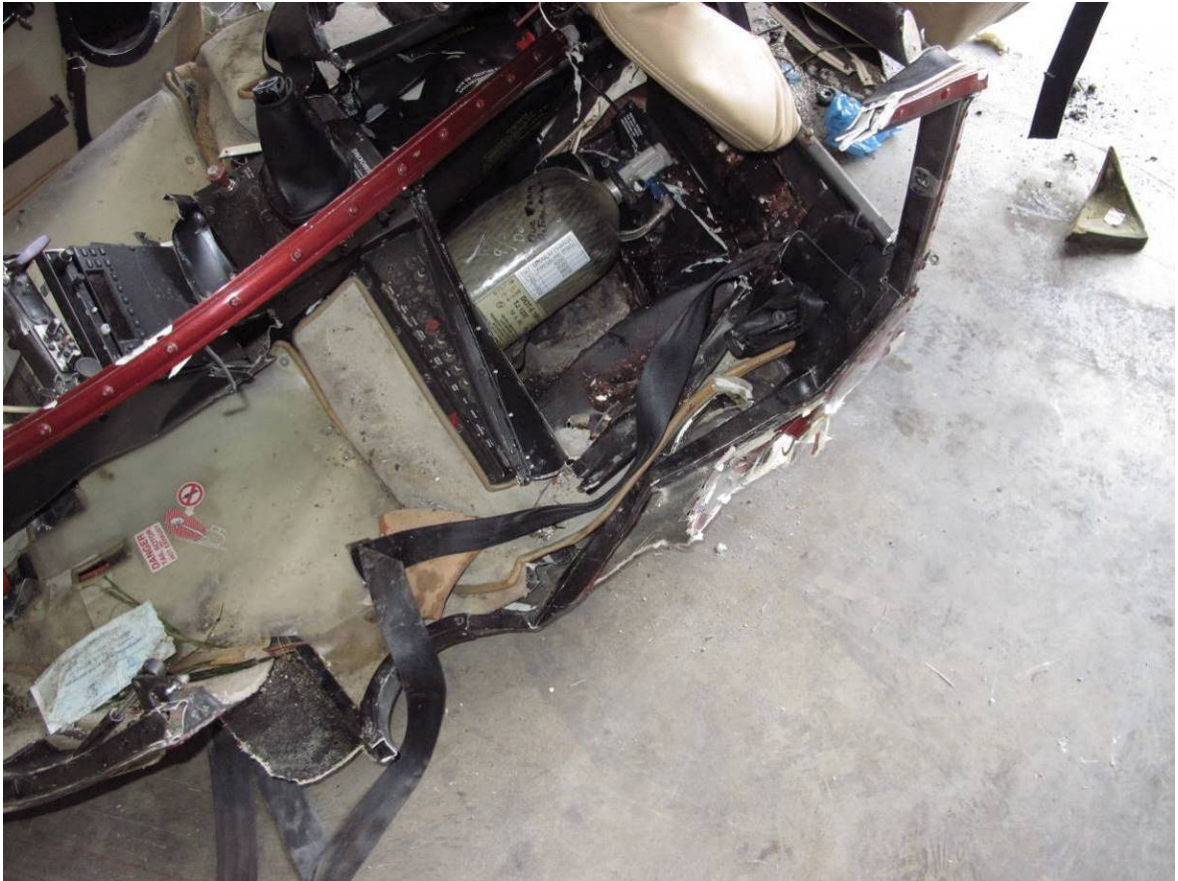
Both floats had some inflated and some deflated chambers. The float gas cylinder remained secure under the front left seat. The pressure gauge on the cylinder showed zero pressure. The floats were deployed at the time of the examination, yet the collective activation lever shear pin was intact.

The pop-out float gas cylinder
